# MANAGEMENT OF PERFORATIONS

DR. SIJU JACOB

## CASE 1: PERFORATION REPAIR IN MAXILLARY FIRST MOLAR

## CASE 2: MULTIPLE PERFORATION REPAIR IN MAXILLARY LATERAL INCISOR

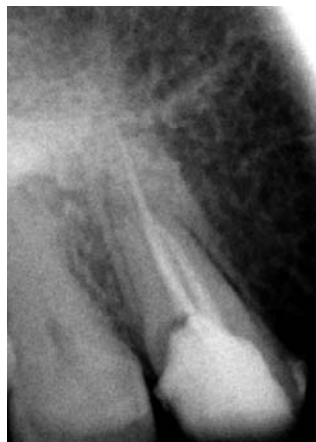
FIG 1a: Straight angled radiograph suggests a missed distal canal

Clinical examination revealed tenderness on palpation of the maxillary right first molar and buccal soft tissue. Periodontal findings were within normal limits. A straight angled radiograph suggested a missed distal canal (**Figure 1a**) where as an of-angled radiograph showed what appeared to be 3 canals filled (**Figure 1b**). The treatment options were discussed with the patient and a decision was made to re-access and re-evaluate the tooth for further treatment.

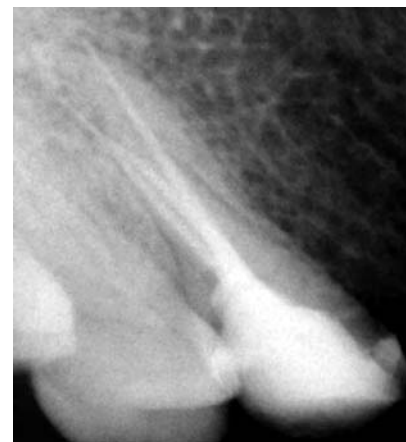
FIG 1b: Off-angled radiograph shows 3 filled canals

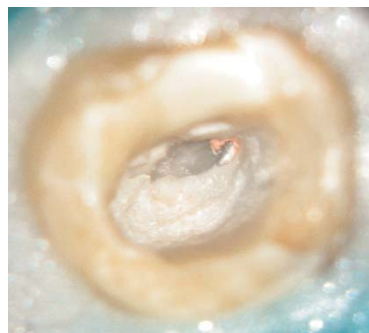
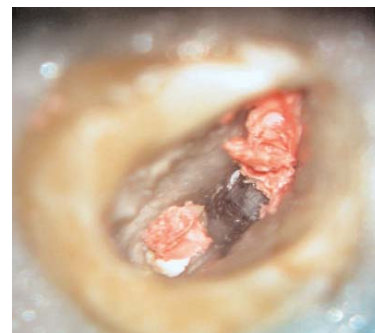
FIG 2a & 2b: Access cavity restoration removed carefully under the microscope using burs and ultrasonics

After anesthesia and rubber dam application, the old composite access cavity restoration was carefully removed using burs and ultrasonics under the surgical operating microscope (**Figures 2a, 2b**). Examination under magnification revealed two filled canals - the mesio-buccal and palatal - and a missed distal canal. A distal perforation was seen wrongly treated and filled as a third canal (**Figures 3a, 3b**).

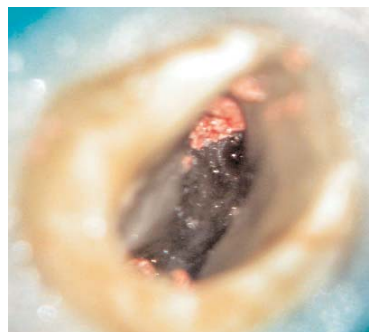
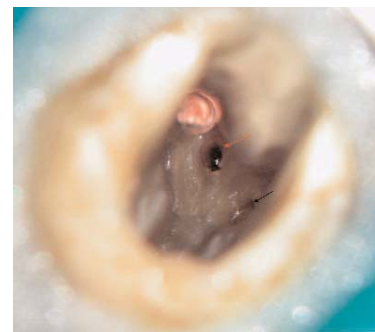
FIG 3a & 3b: Orange arrow shows perforation from which gutta percha was removed. Black arrow shows the missed distal canal.

Gutta percha was removed from the perforation and the filled canals. The perforation was repaired with MTA (**Figure 4a**). All canals were shaped, cleaned and calcium hydroxide placed (**Figure 4b**). Patient was recalled after two weeks. Patient reported

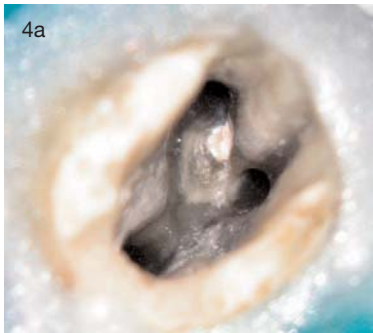
FIG 4a: Perforation repaired with MTA

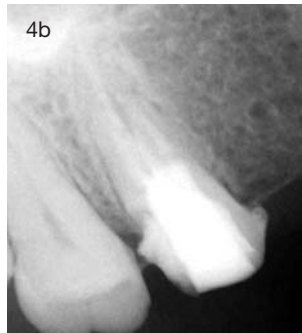
FIG 4b: Canals filled with calcium hydroxide

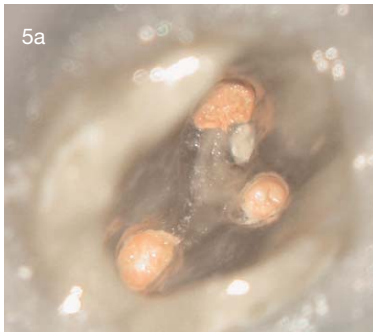
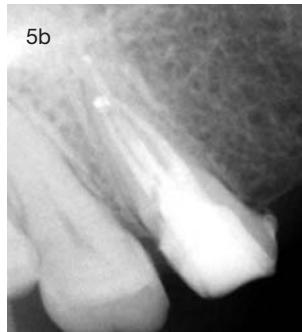
FIG 5a & 5b: Canals obturated with gutta percha. Access sealed with composite resin

asymptomatic and all canals were obturated with Gutta percha and Ah plus sealer in warm vertical condensation technique (Figures 5a, 5b). The Access cavity was sealed with composite resin and patient was referred for a new crown.

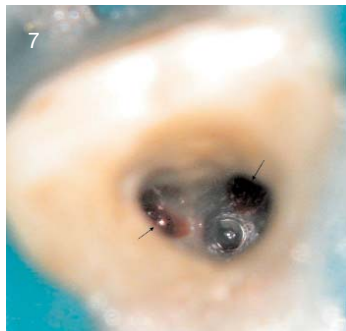
FIG 6: Pre-operative radiograph showing patent canal and evidence of perforation

FIG 7: Black arrows denote the two perforations

Clinical examination revealed severe tenderness to palpation in the left maxillary lateral incisor tooth and labial soft tissue. Radiographic examination revealed a patent canal and evidence of perforation (Figure 6). Treatment options were discussed with the patient's parents and a decision was made to re-access and re-evaluate the tooth for further treatment.

After anesthesia and rubber dam application, the temporary filling was removed and the access cavity was observed under the surgical microscope. Two perforations were observed (Figure 7). The actual canal was located palatal to where the perforations were present (Figure 8a, 8b). The actual canal was cleaned, shaped and filled with calcium hydroxide. The perforations were sealed with MTA (Figure 9). The patient was recalled after 10 days. The MTA was verified to have set and sealed the perforations and the canal was obturated with gutta percha in warm vertical condensation (Figure 10a, 10b). The Access cavity was sealed with glass ionomer cement injected through a centrix needle (Figure 11).

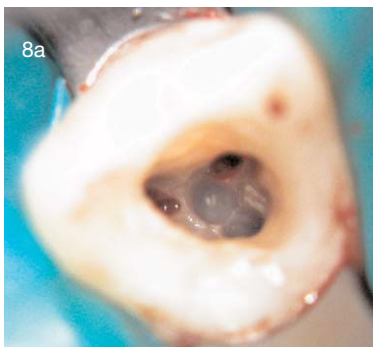
FIG 8a: Actual canal located palatal to the perforations

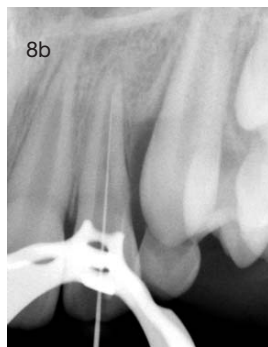
FIG 8b: Wire film confirms canal location

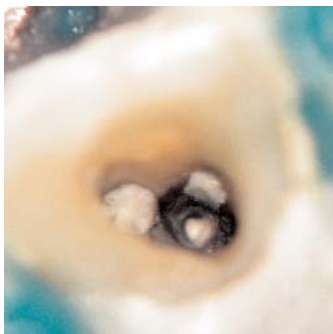
FIG 9: Perforations repaired with MTA

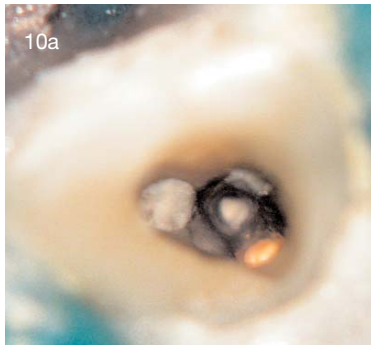
FIG 10a: Chamber photograph showing obturation of the canal with gutta percha and perforation repair with MTA

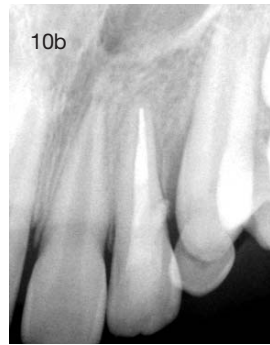
FIG 10b: Post obturation radiograph

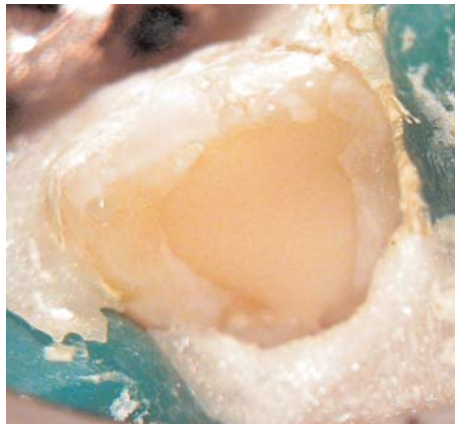
FIG 11: Access cavity sealed with glass ionomer cement
